**SPE 120762**

## **Recovery Of An Oil Producer Severely Damaged By OBM Using An Advanced Barite Dissolver System**

C. Davies, SPE, A. Twynam, SPE, BP, and R. Harrington, SPE, WFI

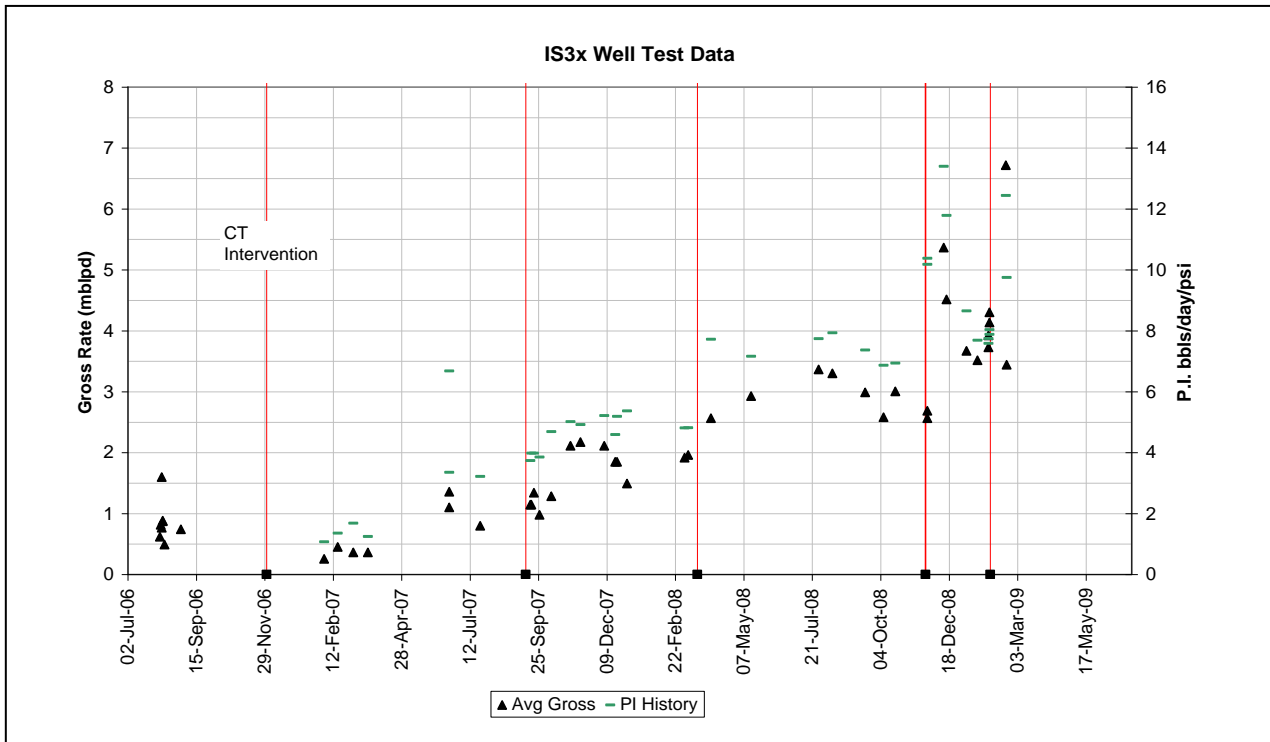
Figure 4: Chart summarizing average gross well rates and increases in well productivity over the period of bull head operations from September 2007 to February 2009. The CT intervention date is also shown.

Calculating productivity changes between interventions 4 and 5 was difficult as a very limited amount of quality well tests were performed between the interventions. There were several well tests where the well was not stable so calculation of the PI could have a significant error. There is evidence that intervention 5 contributed to an increase in well productivity. Figure 4 shows a graphical summary of the well PI changes during the bull head operations.

The application of this chemical system through bullheading has proved to be both a cost effective and efficient system for increasing well productivity which has been impaired through mud damage. A chart summarizing the step changes in well productivity is shown in figure 4. Other key conclusions are:

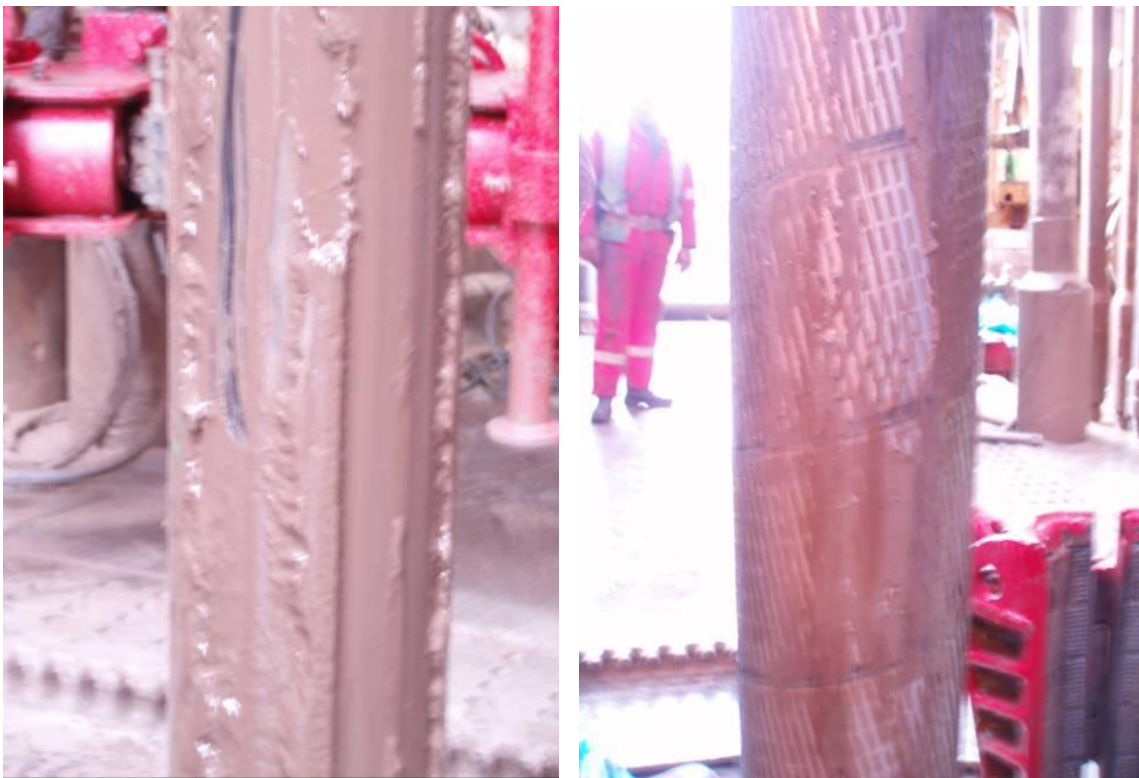
Picture 1: Screens that were pulled out from the aborted 1<sup>st</sup> completion run with shroud covered with mud solids. The picture on the left shows one of the lowest screen joints as it was removed from the well. A higher joint shown in the right picture which had not entered into the PDL showed slightly less mud coating but the screen shroud was still blocked.

During the initial running of the 5 ½" sand screens weight loss was encountered as the screens were entering the PDL. Despite several attempts to work the screens through, the completion run was aborted with only the bottom 2 to 3 screen joints believed to have entered the PDL. Sagging was exhibited in the mud during these operations. After retrieving the screens it was determined that the screens couplings and shroud had been compacted with mud solids due to mud sag (Pictures 1, 2 and 3). The top section of screens also contained small pieces of shale in the screen shroud (less than 1% overall). After a cleanup trip the screens were successfully re-deployed and installed in the PDL, with the SC-2R packer successfully set and tested.

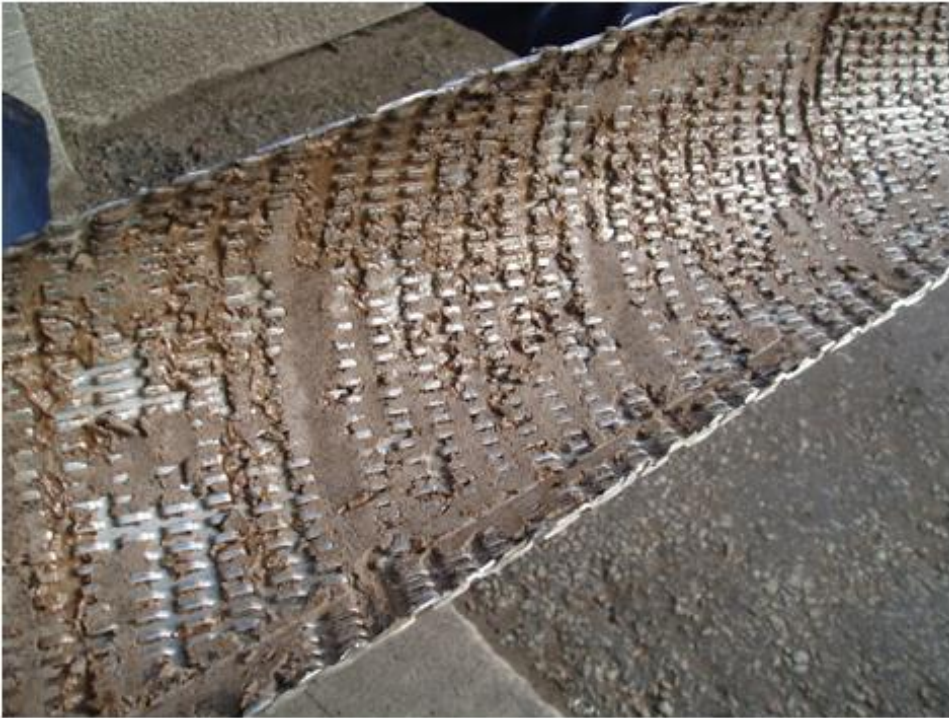
Picture 2: mud coated on inner section of screens shroud from aborted 1<sup>st</sup> completion run.

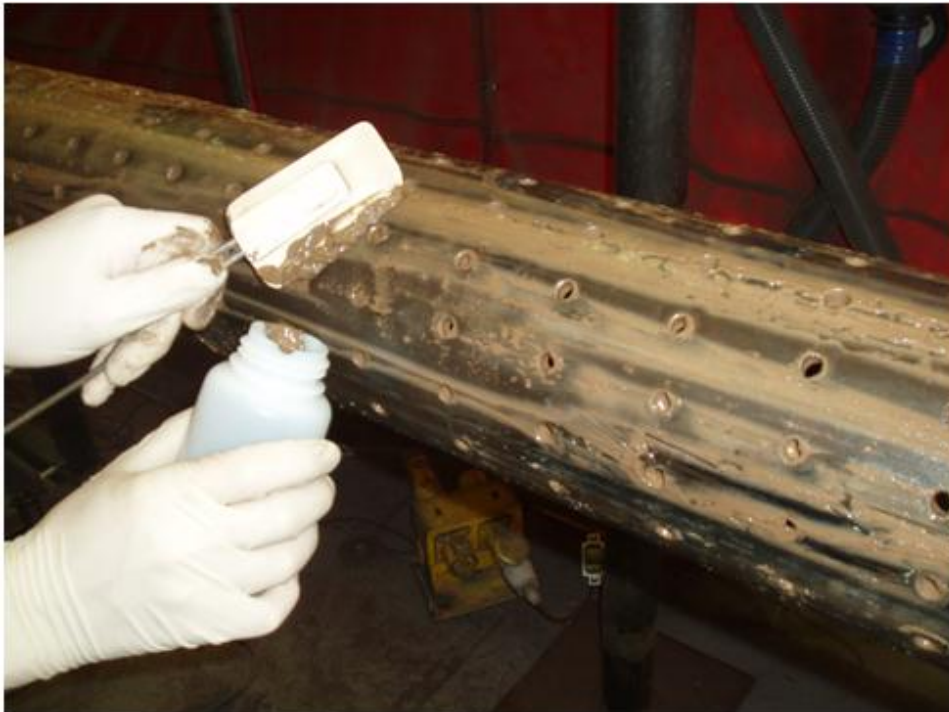
Picture 3: sample of mud solids being retrieved from the base pipe of the screen from the aborted 1<sup>st</sup> completion run for lab analysis.

The production for this length of completion was anticipated to be 4,000 bld; it began at 800 bld but dropped rapidly to 400 bld. Due to the very poor results, an intervention was planned based on the results of extensive laboratory testing of chemical solutions to remove the OBM solids from the well. Lab testing was based on the analysis of deposits recovered from the aborted first set of screens, which found the deposits to be 60 to 65% barite and 15% calcium carbonate with solids sizing less than 90 microns, most sized below 45 microns.
