Technical Data

Corrosion & Elastomer Impact
Specifications

HDC Mk II, Pyrosol ES,
PentaFlow Products

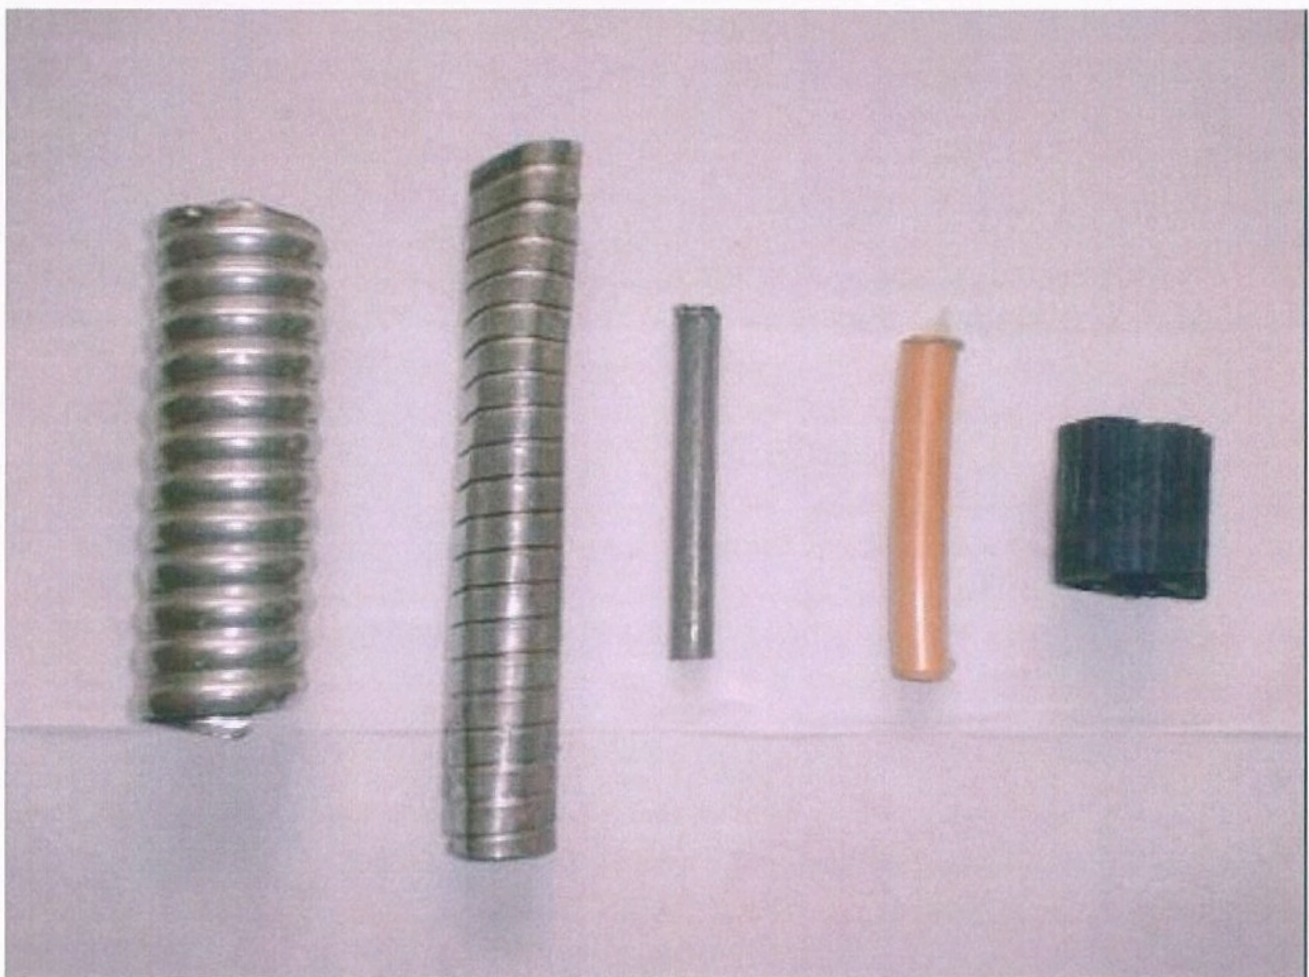
Photo 1: Components prior to testing

48 hour static aging of components in Pyrosol ES and PentaFlow

Sample	Initial Weight	Final Weight	Observations
Cable 1	39.2g	39.0g	No pitting or discoloration; Minor weight loss due to tape residues washed off
Cable 2	41.55g	41.55g	No Change
Exterior (black) insulation	8.4g	8.4g	No Change ; no change in elasticity or colour
Orange Insulation wire	22.4g	22.4g	No Change
Lead insulation wire	24.6g	23.15g	Weight loss due to pitting and etching of lead surface

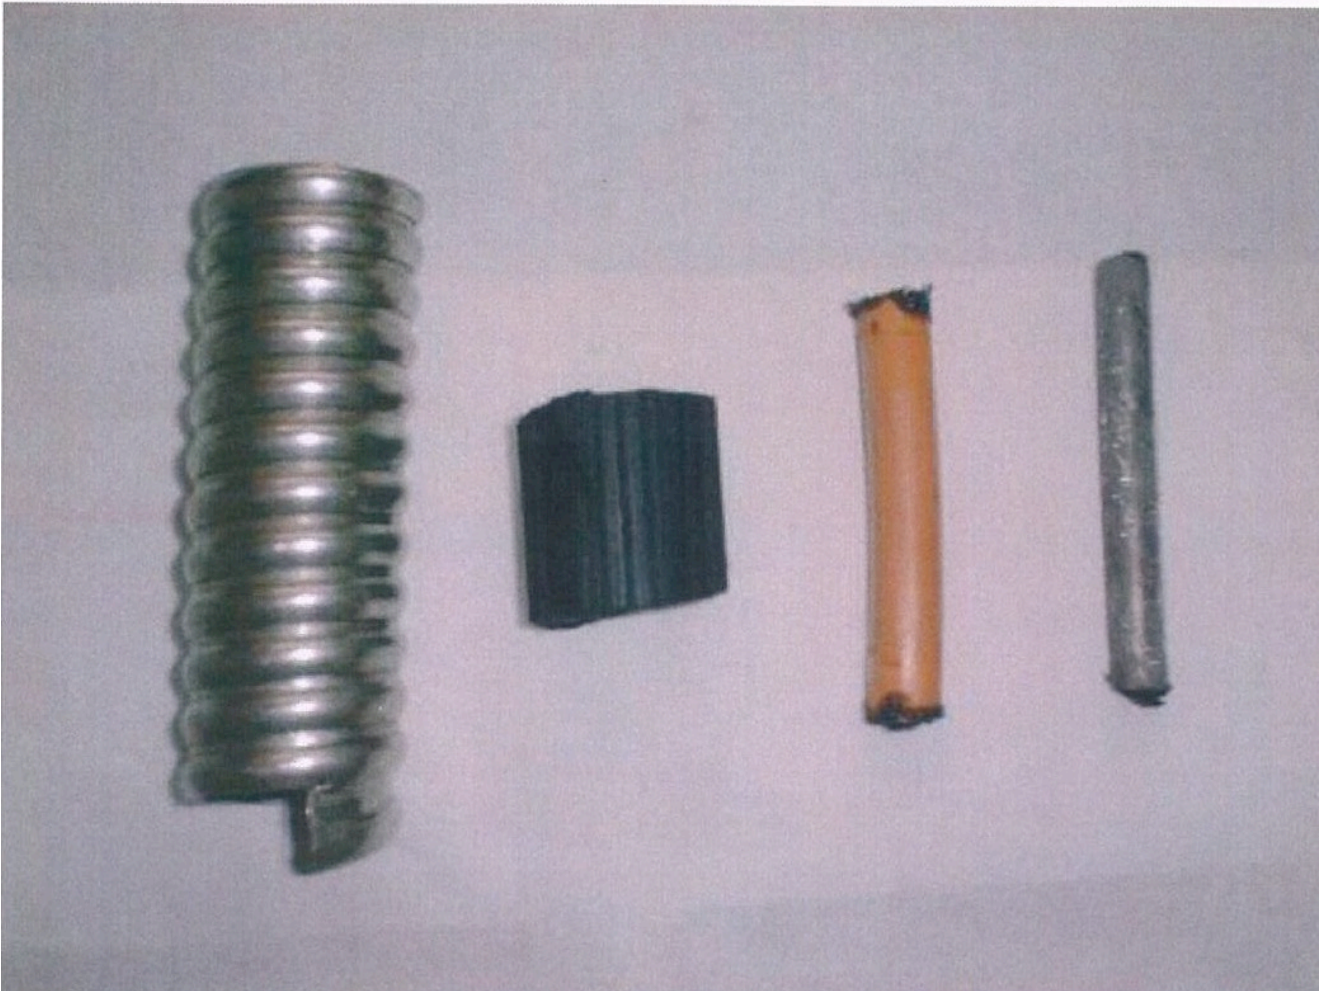
Photo 2: Post Static Aging - note pitting on lead wire surface; discoloration at wire ends due to absorption of product on epoxy resin sealant
